PBHE's Response to Technical Safety BC's Report on

The 3 Fatalities due to Ammonia Release at Fernie Memorial Arena - Oct. 17, 2017

Co-Authors: Brian Holtham, President of PBHE

Date: August 28, 2018

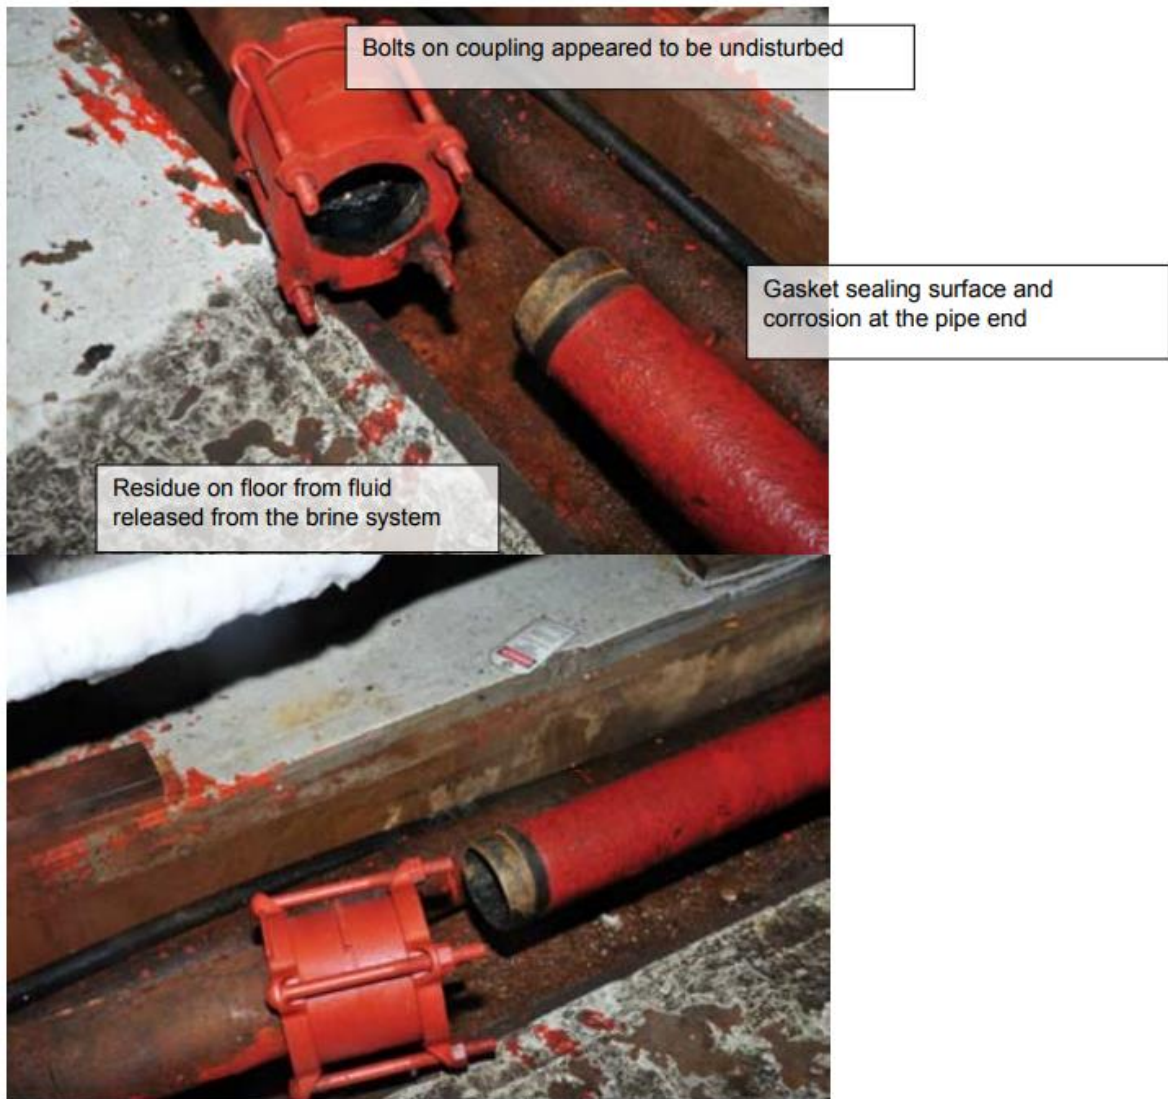
C5 Separated Coupling

Photo C5-1 and Photo C5-2: Separated brine system coupling.

Photos C5-1 and C5-2 show the coupling dislodged from the piping. The report discusses the configuration of the piping components observed after the incident.

The above two pictures are of the four inch pipe that separated when the internal pressure reached somewhere between 40 to 150 psi which instantly saturated the machine room with up to 22,000 ppm anhydrous ammonia. According to Technical Safety BC's graph the machine room was still above 10,000 ppm ten minutes after the pipe burst. (Technical Safety BC. *"Investigation Report Ammonia Release – Fernie Memorial Arena - Appendices"* 2018, Page 30)

1. The brine system should have had a pressure release valve with the appropriate drain lines and associated dump tank vented outdoors. This is standard for all pressure systems and should be part of the recommendations. A 25 psi pressure release valve limit should be set since research found that "the four inch pipe-coupling joint was pressurized and at 30 pounds per square inch (psi) the coupling began to slip toward separation." (Technical Safety BC. *"Investigation Report Ammonia Release – Fernie Memorial Arena."* 2018, Page 14)

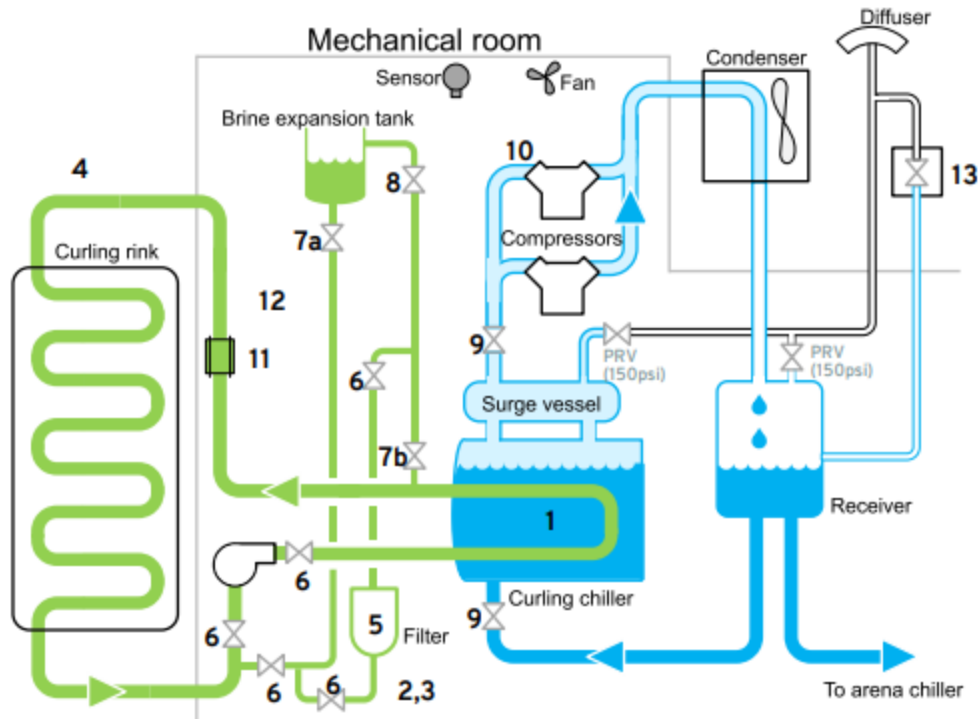
2. Given the schematic shown in Figure 3, there are multiple ways that the brine system could be pressurized by the ammonia system. (Technical Safety BC. *"Investigation Report Ammonia Release – Fernie Memorial Arena."* 2018, Page 9) It is not uncommon to have a major rupture in a heat exchanger and this condition should have been anticipated.

Figure 3: Schematic of the Fernie Memorial Arena curling refrigeration system. Numbers identified correspond to the items and descriptions in the Table 1 below.

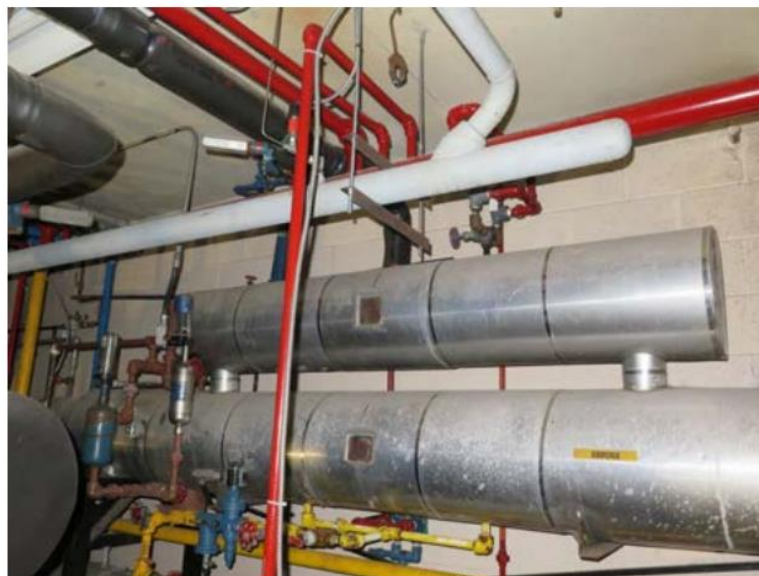
3. The age of the chiller is not visually obvious when they are covered in aluminum cladding (as shown in Photo C3-12). (Technical Safety BC. *“Investigation Report Ammonia Release – Fernie Memorial Arena - Appendices.”* 2018, Page 56)

Photo C3-12: Curling chiller (with insulation) showing the ammonia liquid inlet configuration. Valve positions are noted in Appendix B.

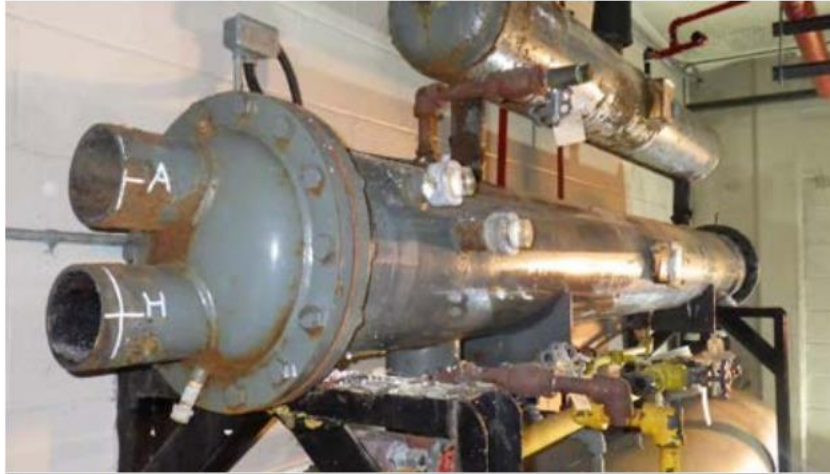
C3 Curling Brine System Chiller

However, when the cladding is removed (as shown in Photo C3-1) the age and state of the chiller is quite apparent and concerning. (Technical Safety BC. *“Investigation Report Ammonia Release – Fernie Memorial Arena - Appendices.”* 2018, Page 51)

Photo C3-1: Curling chiller with the brine inlet and outlet piping removed. The photo below shows the curling chiller with its head removed, exposing the tube sheet.

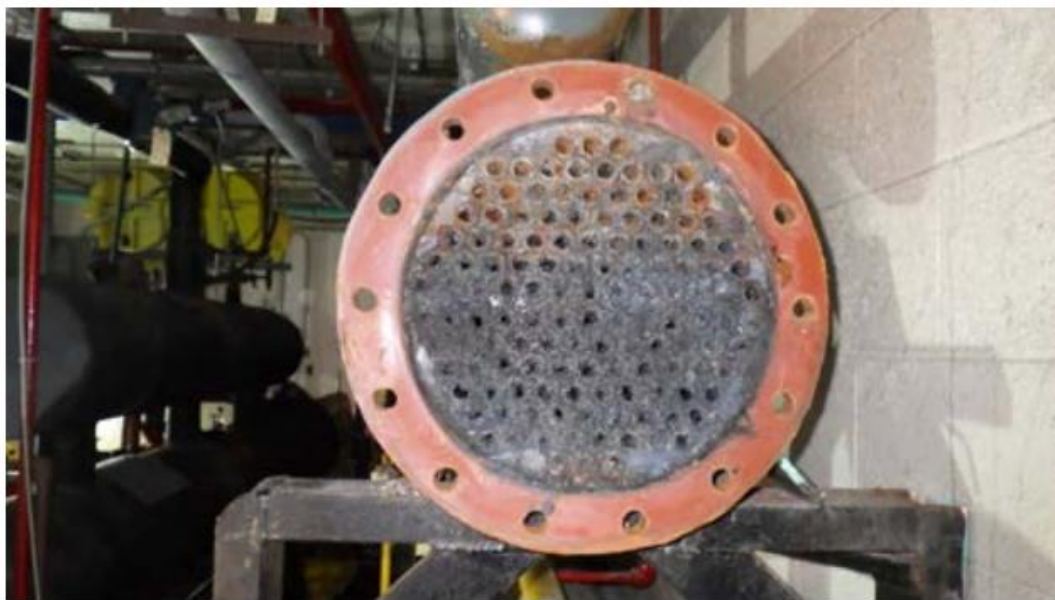
4. Calcium chloride brine, tube welds and time (31 yrs.) was the cause of the tube leak. Technical Safety BC's recommendations should identify the corrosive power of calcium chloride brine and therefore be considered when setting chiller life span. A glycol solution is less corrosive to chiller tubes but is less efficient than a calcium chloride brine solution. With the end covers removed, it is apparent that all of the tubes were in severe condition (shown in photo C3-4 and C3-5 below).

Photo C3-4: Curling chiller, tube sheet upon opening in January 2018 showing residue.

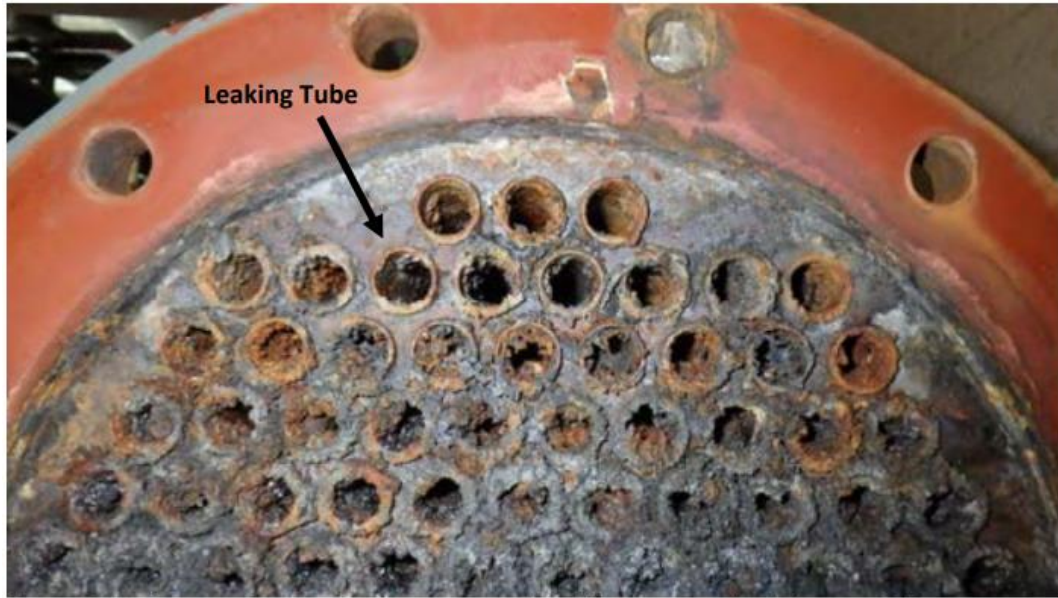
Photo C3-5: Close up of upper tubes from return end of chiller upon opening in January 2018.

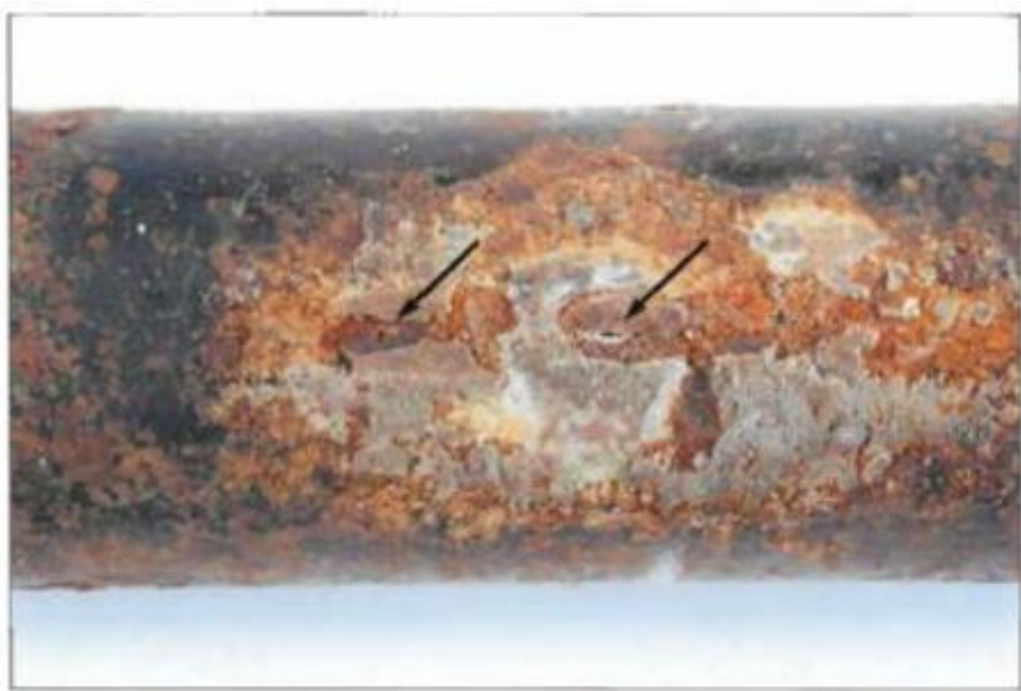
5. In industrial heat exchangers there is generally a documented inspection and maintenance procedure which includes tube cleaning. This is often done on a regular basis to increase efficiency. The conditions of the tubes indicate there was no such procedures in place. The Photo below (Figure 107) shows the external view of the leaking pipe. (Technical Safety BC. *"Investigation Report Ammonia Release – Fernie Memorial Arena - Appendices."* 2018, Page 166)

Figure 107 Main leaking defect on row 2 – tube 3 removed from bundle. Several smaller defects were found along the ERW weld.

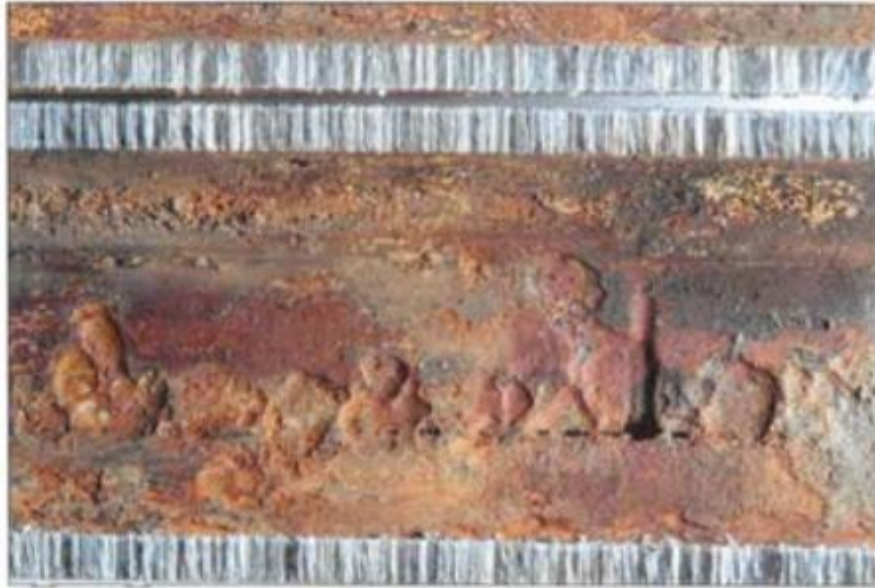
The below photos show the inside of the leaking pipe before and after it was cleaned. (Technical Safety BC. *"Investigation Report Ammonia Release – Fernie Memorial Arena - Appendices."* 2018, Page 171) The cleaned pipe shows excessive corrosion, reducing the metal thickness ultimately leading to the accident. This type of corrosion was found on all the pipes examined.

Figure 117 Closer view of leaking defect showing a line of "stitch-like" defects adjacent to the leaking defect. Nozzling effect has removed material above the leak.

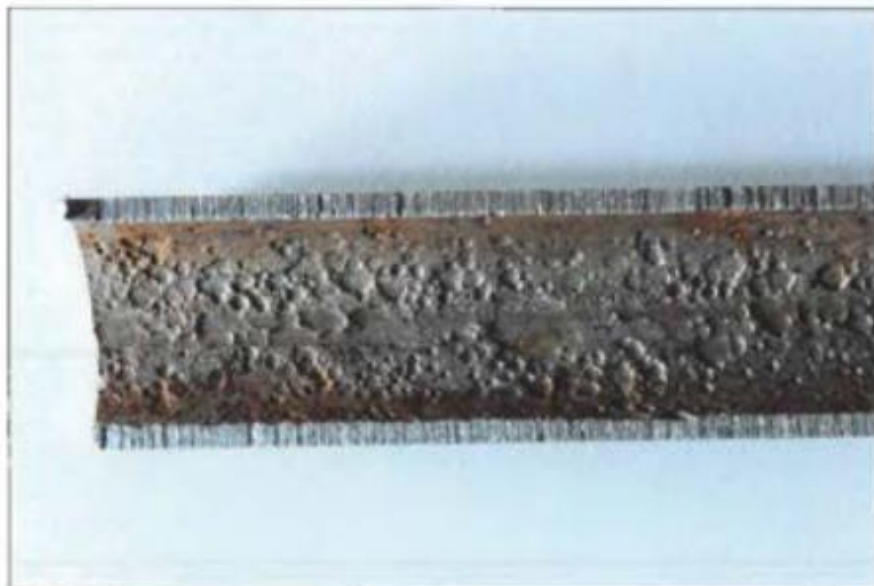
Figure 118 Typical corrosion damage found along row 2 – tube 3 approximately 12" from the leaking defect.

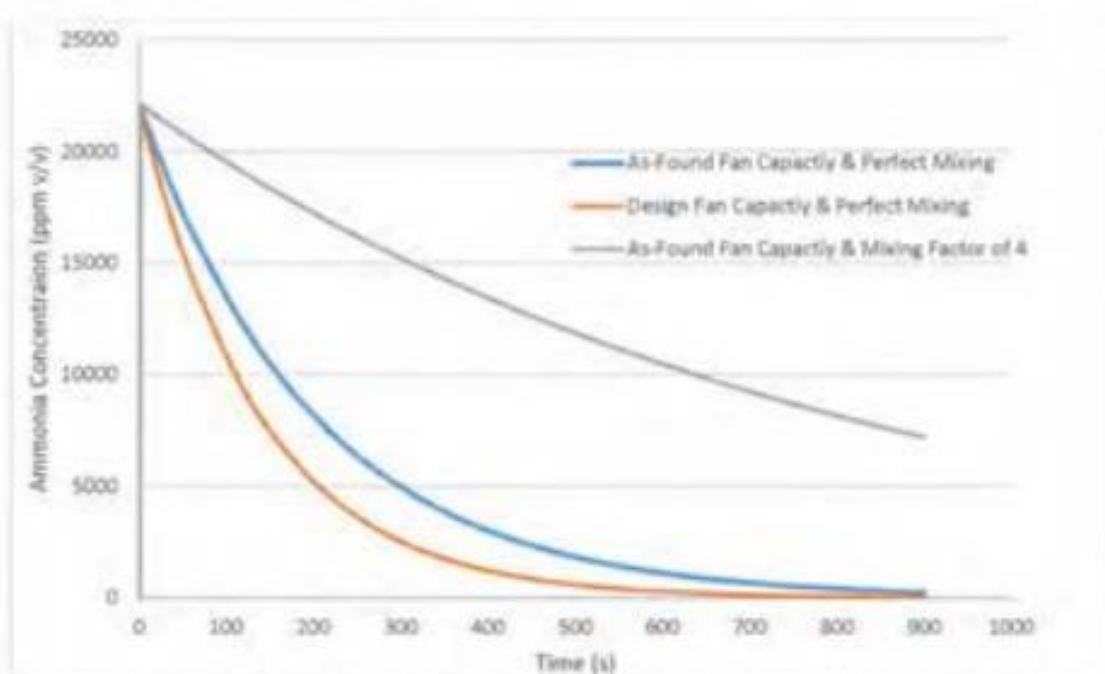
9. The ammonia concentration in the room reached over 20,000 ppm and likely remained above 15,000 ppm for at least 5 minutes. If the ventilation system was functioning with the designed air flow and perfect mixing, the ammonia concentration should have dissipated to below 4,000ppm after 5 minutes. This is shown in the graph below (the resolution quality of the original document is unreadable). (Technical Safety BC. *"Investigation Report Ammonia Release – Fernie Memorial Arena - Appendices."* 2018, Page 30)

Figure 14: The dilution rate of the ammonia in the machine room for a 4 kg instantaneous release of ammonia, assuming a volume averaged concentration.

This is still significantly above the life threatening ammonia levels. The ventilation system was yet another piece of equipment that was not functioning properly.
